AFML-TR-78-90

INVESTIGATION OF REJUVENATION OF FATIGUE DAMAGE IN IN-718

BATTELLE
COLUMBUS LABORATORIES
505 KING AVENUE
COLUMBUS, OHIO 43201

TECHNICAL REPORT AFML-TR-78-90
Final Report January 1976 -- January 1978

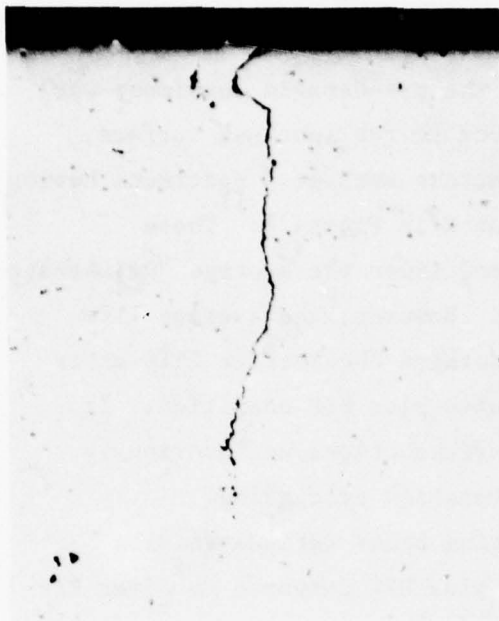
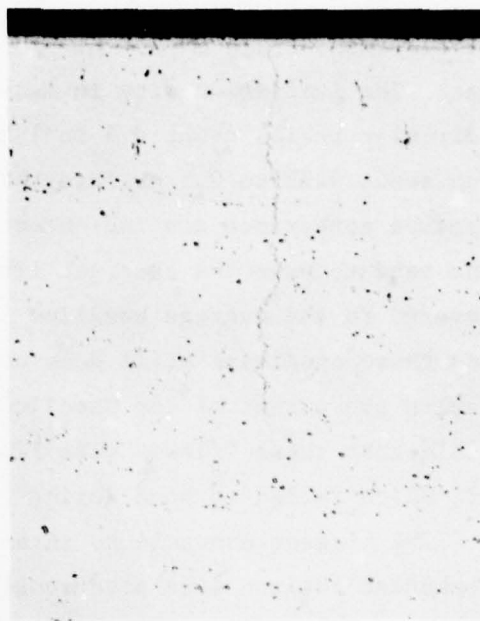
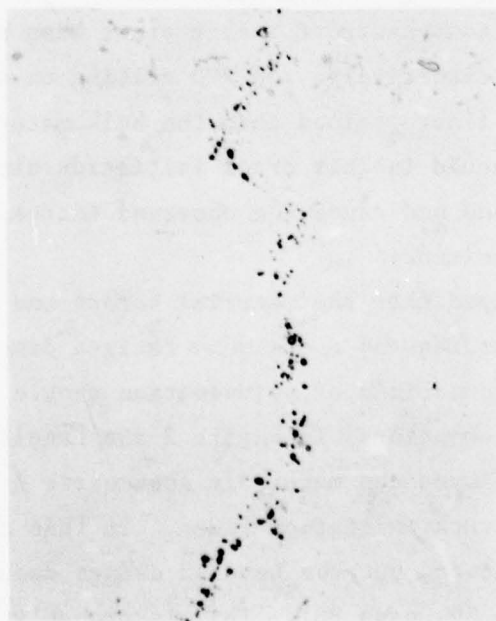
(a) Typical fatigue crack before rejuvenation processing

(b) Typical fatigue crack after rejuvenation processing, as-polished

(c) Same fatigue crack after rejuvenation processing, as-polished

Figure 3. Comparison of Fatigue Crack Appearance Before and After Rejuvenation Processing.
Figures (b) and (c) Show the Appearance of a Crack Which Has Been Closed and Bonded by HIP but Whose Location Is Marked by Second Phase Particles and Possibly Voids.

Metallographic sectioning of fatigue damaged specimens before and after rejuvenation processing showed that fatigue cracks were closed and bonded during HIP. Specimens having crack locations mapped after pre-damage were sectioned after rejuvenation processing and fatigue testing to failure. The locations of the previously existing cracks were marked by small second phase particles and possibly voids, indicating a closed and nearly bonded crack. A typical crack before bonding is shown in Figure 3a. A typical bonded crack is shown in Figures 3b and c in the as-polished and the etched conditions. It should be noted that these cracks did not reopen during fatigue testing subsequent to HIP.

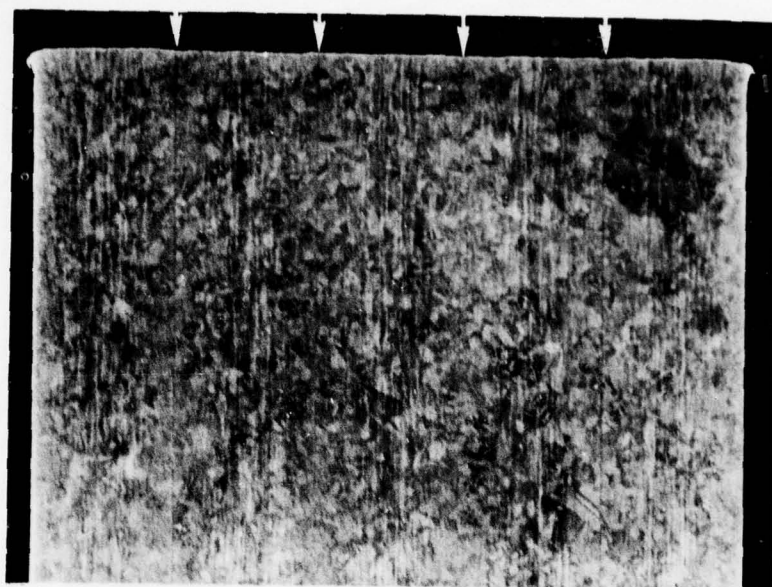
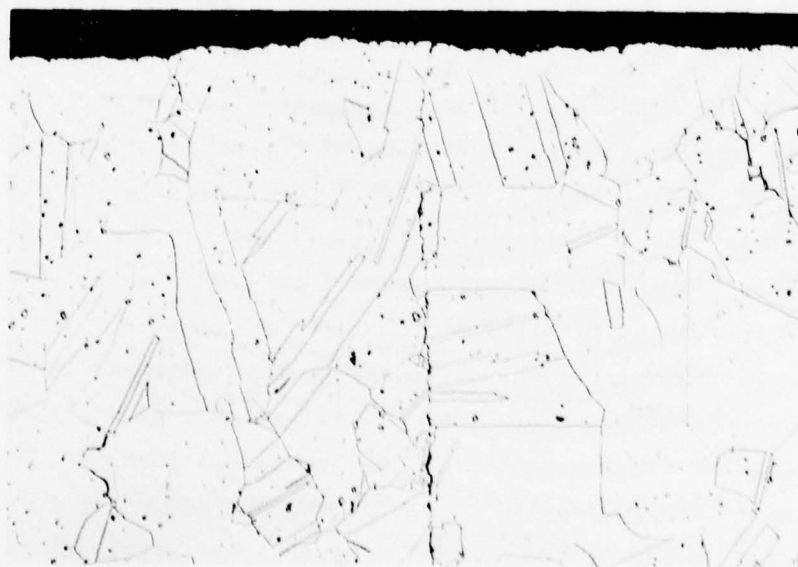
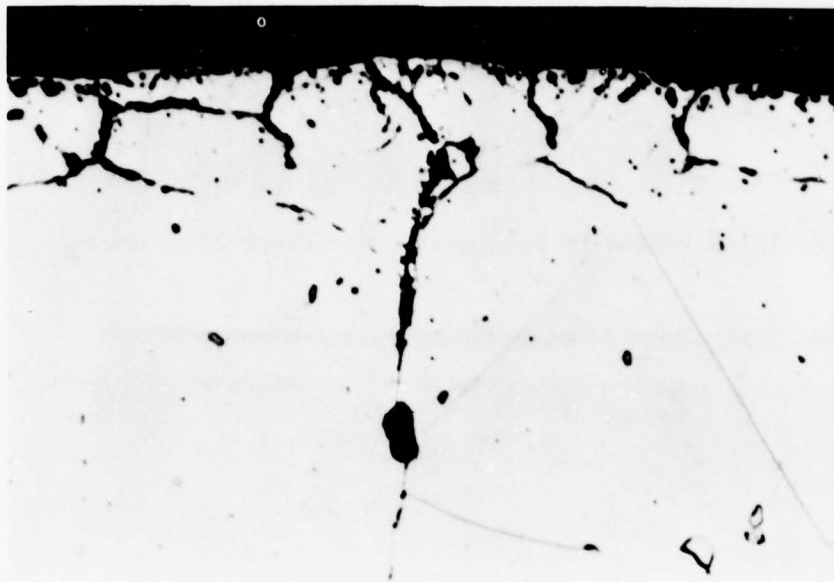
(a) Cross section of the specimen with the arrows showing the locations of the four cracks

Figure 12. Simulated Crack Specimen No. 8, Shot Peened and Ceramic Coated then HIP, Showing Crack Closure and Bonding

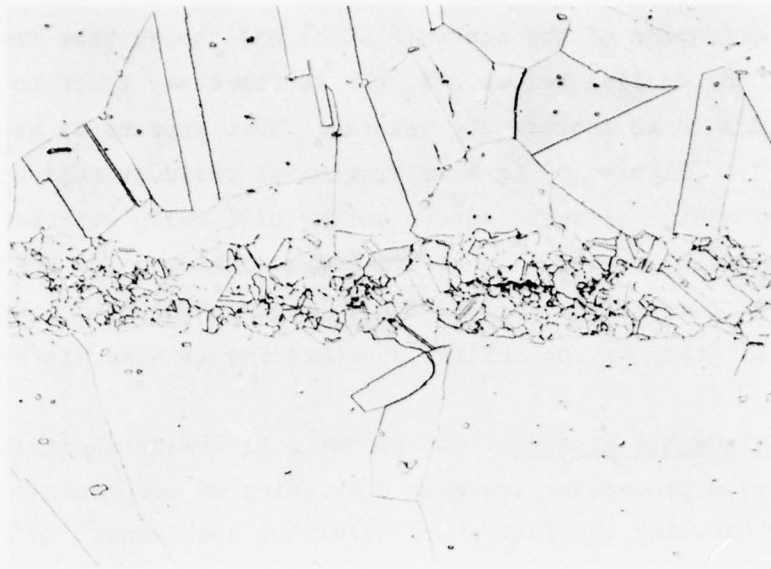
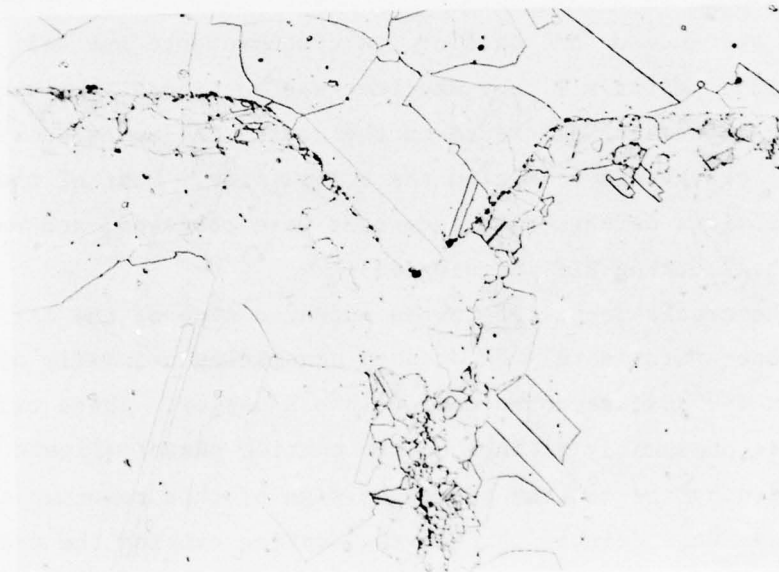
In Specimen 2, which was oxidized and then cleaned before having a lid welded over the top of the cracks, the interface had an appearance as shown in Figure 17. The cracks had all closed, but instead of a simple bond line, a layer of finer grained material lined each side of the bonded crack. The bond appears to be very good; only in a few places was the position of the original bond line discernible (Figure 17a). Although both the top and crack surfaces of the oxidized specimen had the fine grained layer, the cover plate, which had not been oxidized, did not show this effect (Figure 17b). The wedging of the top plate into the crack (Figure 14b) happened because this particular crack was a wide crack. The cause for the fine grained region is not certain. The sheet used for these specimens was cold rolled and aged. One rationale is that subsurface internal oxidation or nitride or carbide formation occurred during oxidation and these particles inhibited grain growth in this layer during HIP. Any compositional changes in this reaction zone, e.g. enrichment of nickel, may have aided the diffusion bonding process. This observation is interesting in that it suggests that some oxidation of the surfaces to be bonded, e.g. crack surfaces, may be beneficial in producing surfaces which bond well during HIP.

(a) Bond line away from specimen surface

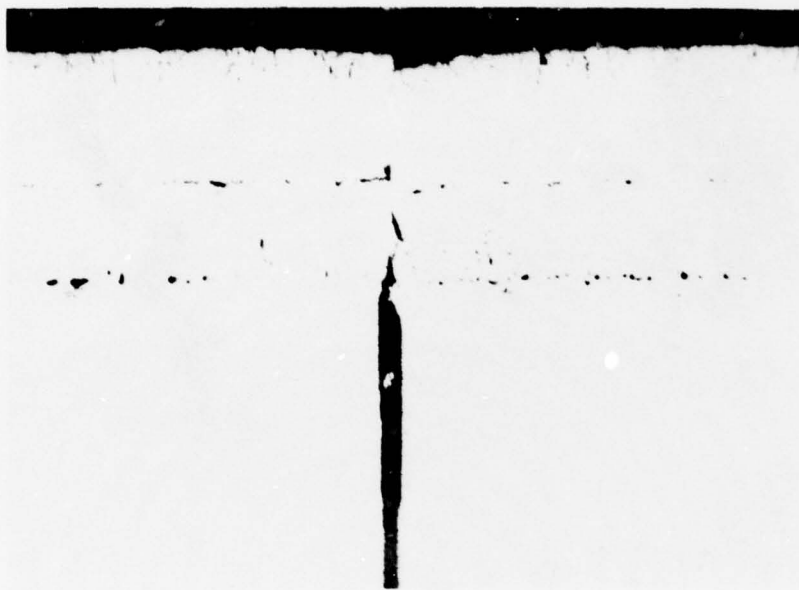
Figure 18. As Polished Surface of Specimen 2-4 Showing
Shift of Opposite Sides of the Crack, Rupturing
the Coating.

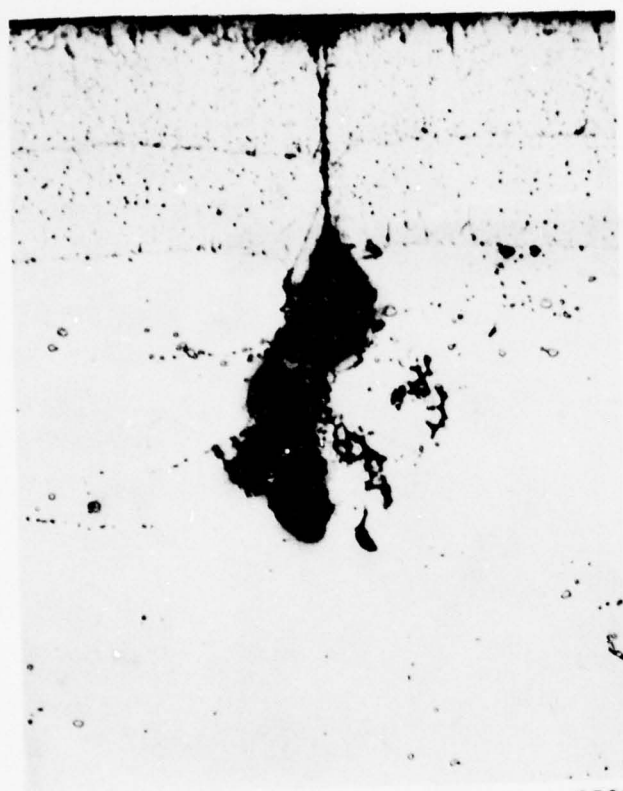
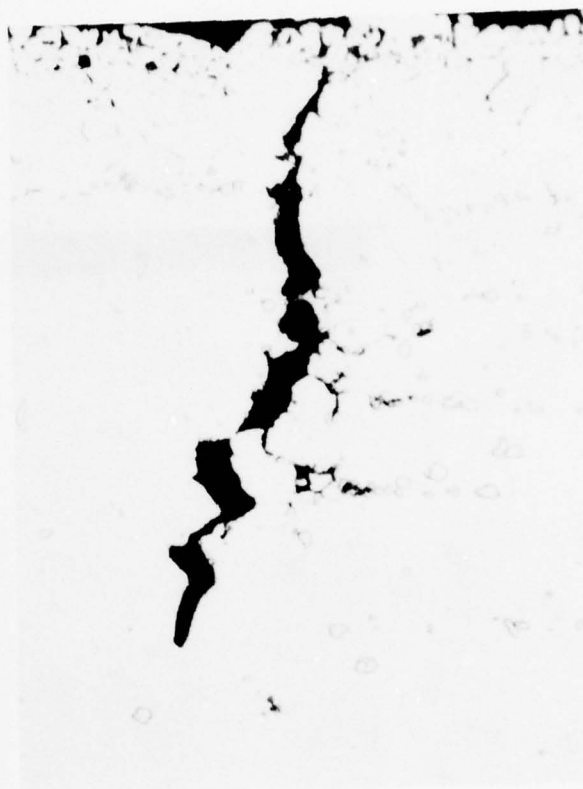
(a) Crack under coating with defect.
Crack opening is about 45 μm

(b) Crack intersecting glass bead shot
peened but uncoated surface of
specimen

Figure 19. Appearance of Secondary Cracks on Coated and Uncoated Surfaces
of Fracture Fatigue Bar 5B-1 after HIP.
The Surface Reaction Zone Which Developed During HIP Extends
about 30 μm Deep Below the Surface. Longitudinal Section.

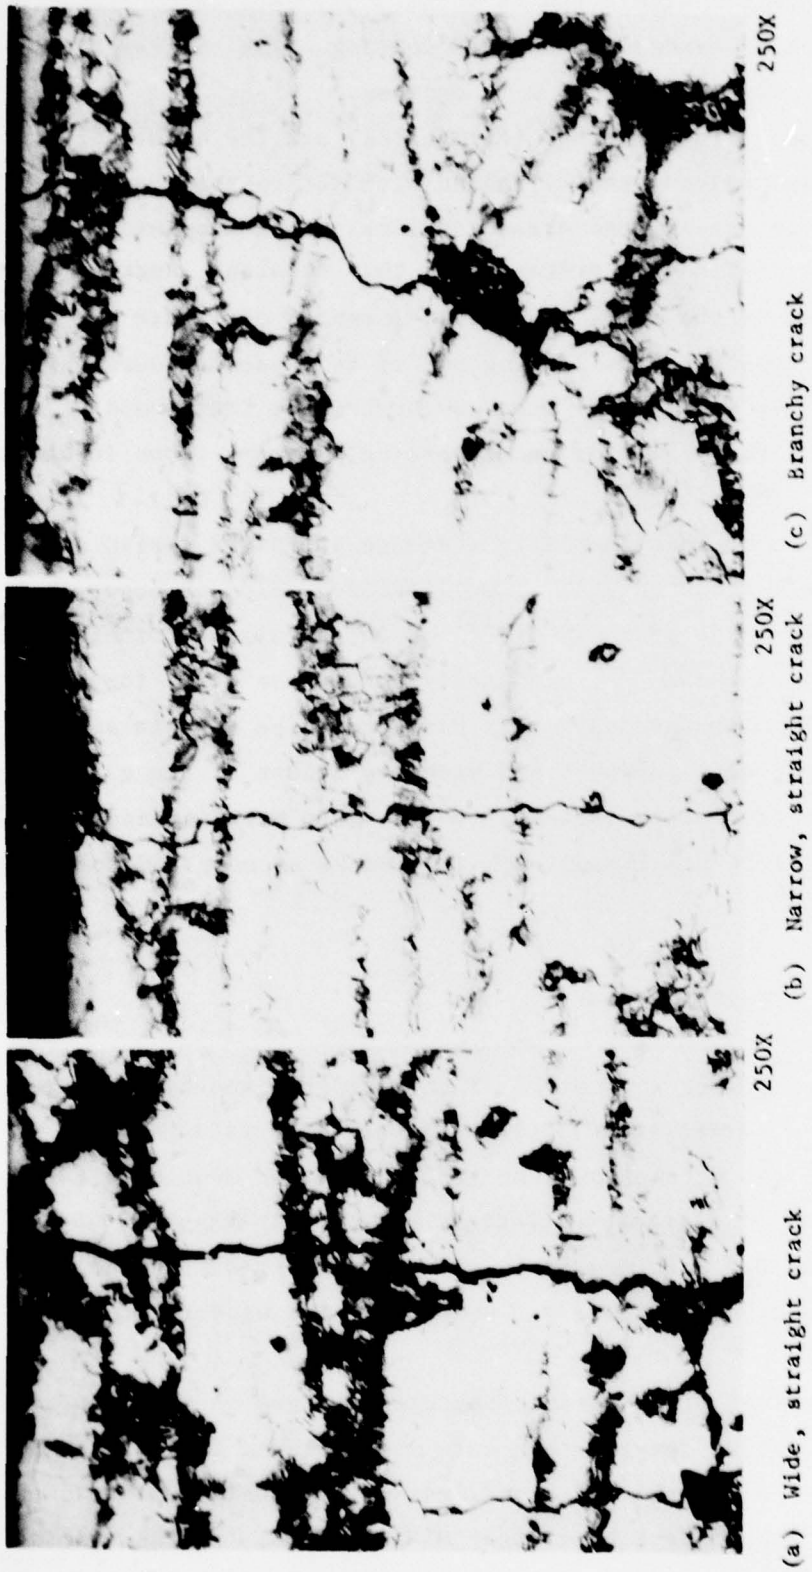
Figure 28. Appearance of Cracks in Unfailed Fatigue Bar Taken to Almost 100 percent of Average Life.
Specimen 5D-2, at $\Delta\epsilon_t \approx 0.80$ percent, longitudinal section.

crack opening width of the wide crack is about 3 μm , well below the 15 to 25 μm range which can be bridged by the PVD coating. The tighter cracks have surface crack opening widths of 1 μm or less.

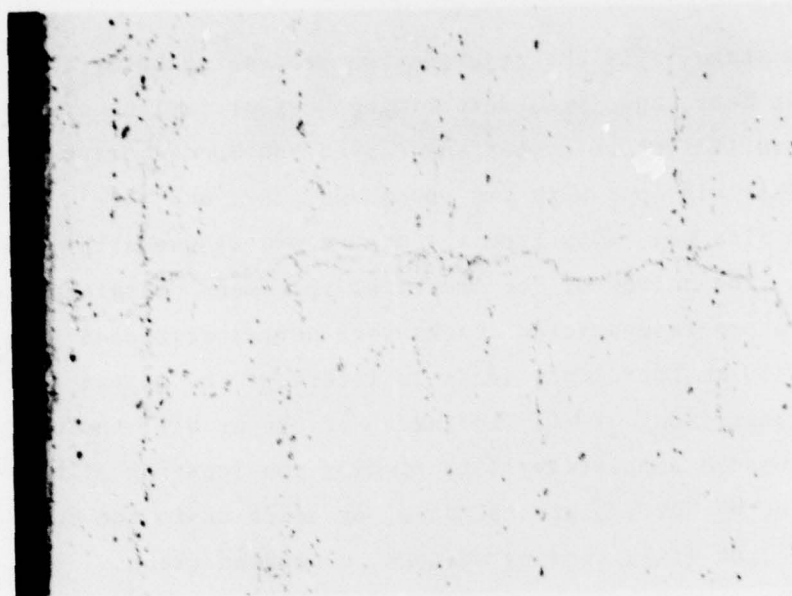
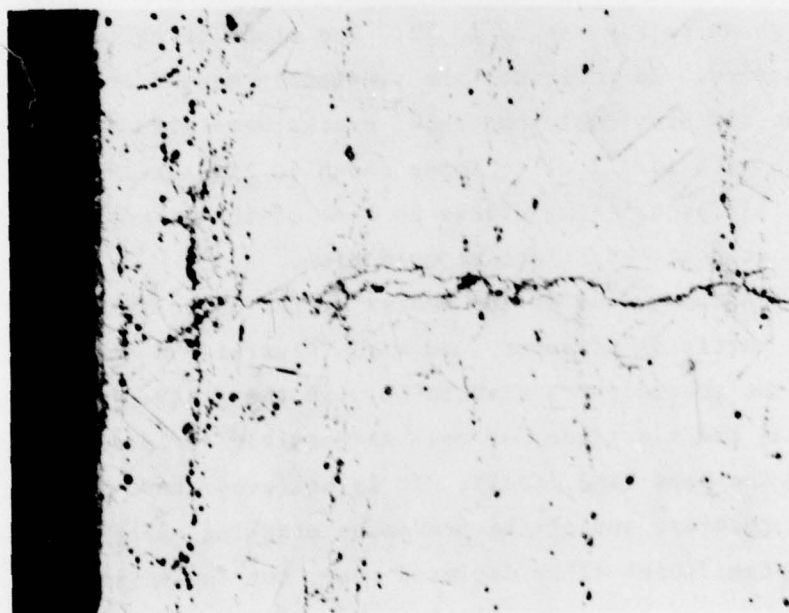
(a) As-polished

Figure 29. Micrographs of a Bonded Fatigue Crack after Rejuvenation Processing and Fatigue Testing to Failure. Specimen 7B-1, longitudinal section.

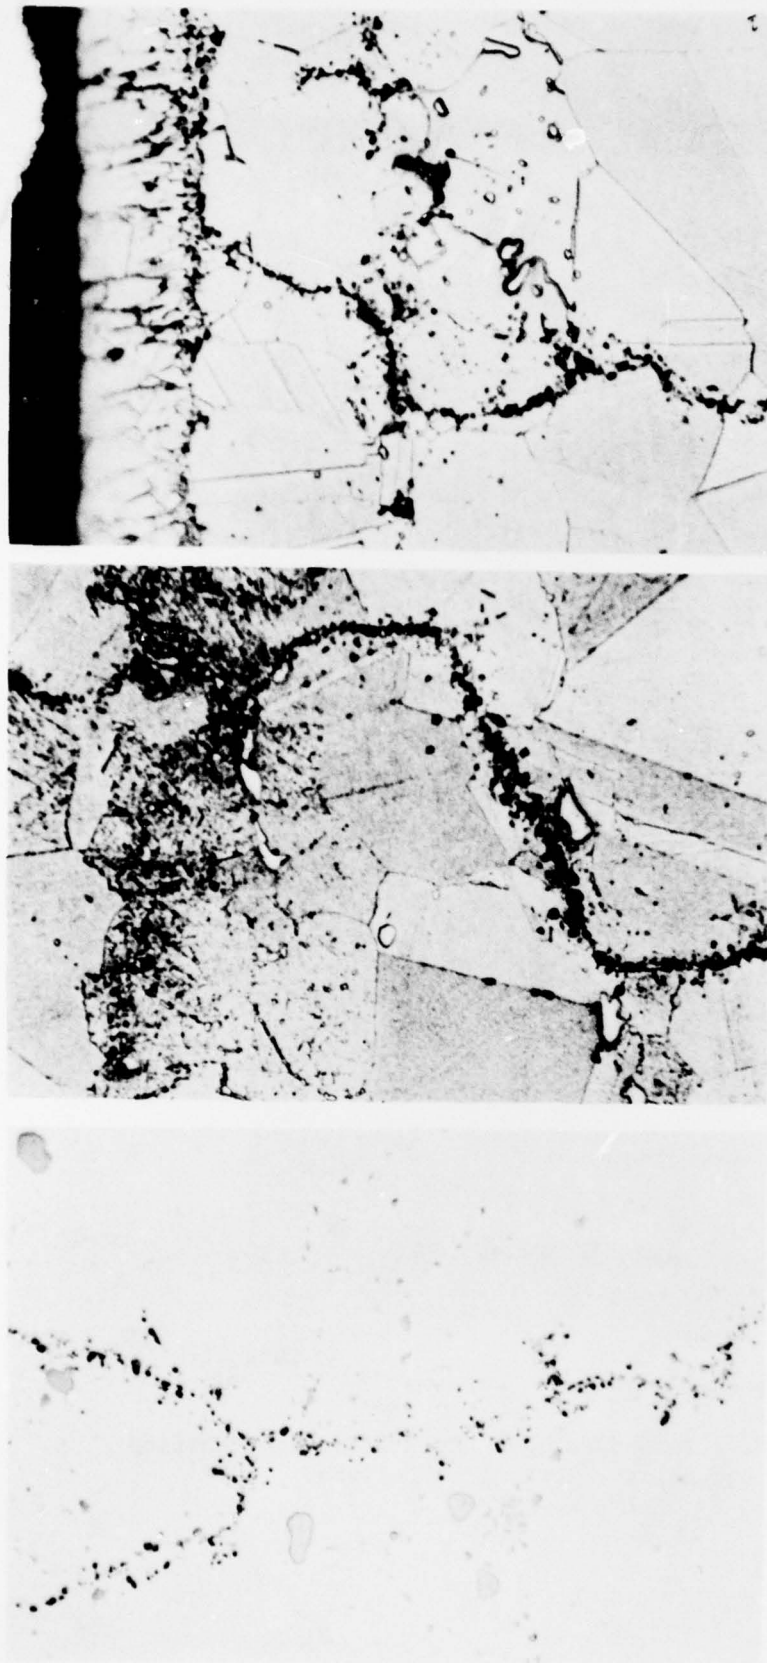
The appearance of the cracks on the as-polished section shows a "track" of particles of about 5 μm wide (Figures 30a and 32a). Therefore, there must be precipitates associated with the crack, lying just beneath the original crack surface, as well as possible residual voids, oxide, or dirt along the bond line itself. It is believed there was not sufficient time at temperature during the predamage cracking phase of testing to develop a significant alloy depleted zone, but the severe etching attack of the cracks over much of their length indicates there must be significant composition differences along the bond line. Since subsequent fatigue did not open up a new crack at or near any of the observed bonded cracks, neither the residual particles, voids, or any alloy depleted zone represented most-favored sites for subsequent fatigue crack initiation. The particles would not be expected to act as initiation sites because of their small size, less than 1 μm .

Figure 30. High Magnification Micrographs of Same Crack Shown in Figure 29.

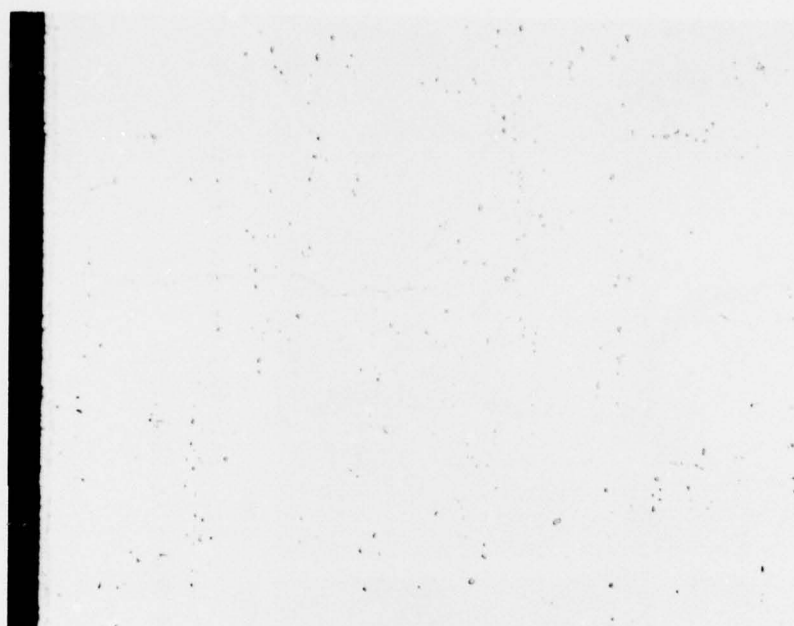
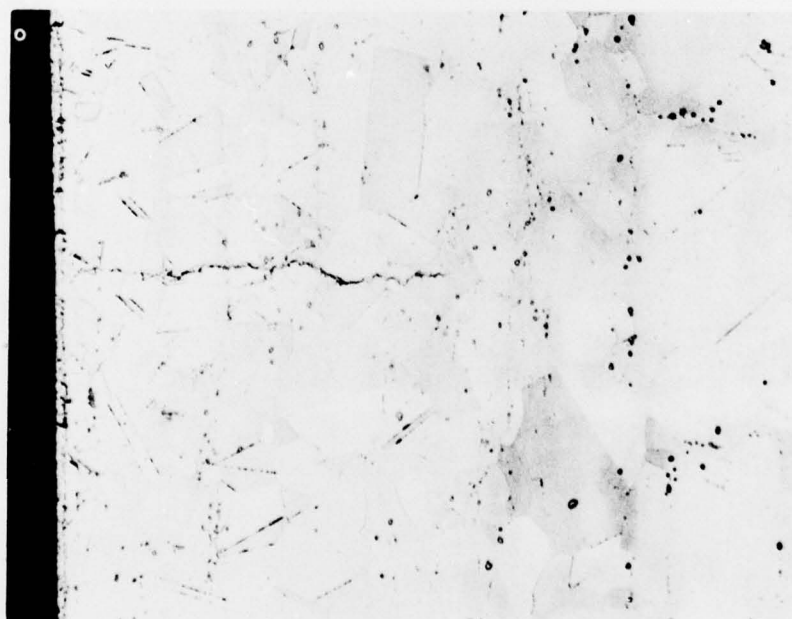
(a) As-polished

Figure 31. Micrographs of a Bonded Fatigue Crack After Rejuvenation Processing and Fatigue Testing to Failure.

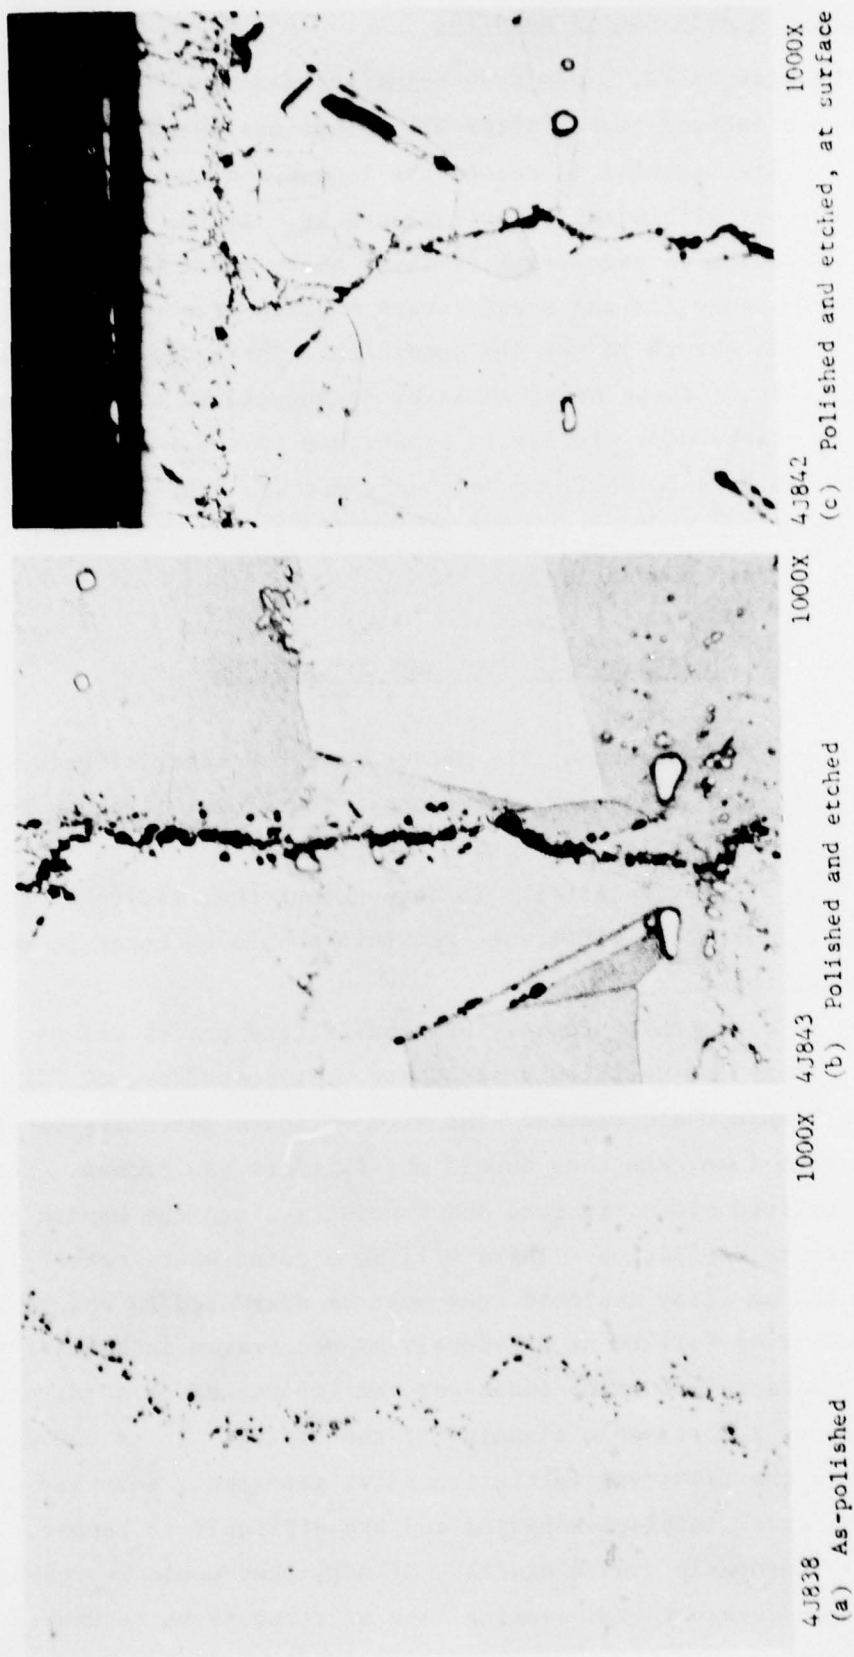
Figure 32. High Magnification Micrographs of Same Crack as Shown in Figure 31.
